*TRAFFIC ENGINEERING  
DEMONSTRATION PROJECT ON  
U.S. 52 BYPASS  
INVENTORY, ANALYSIS AND RECOMMENDATIONS*

*MAY 1966  
NO. 8*

*Joint  
Highway  
Research  
Project*

*by  
G. A. SHUNK  
AND  
H. L. MICHAEL*

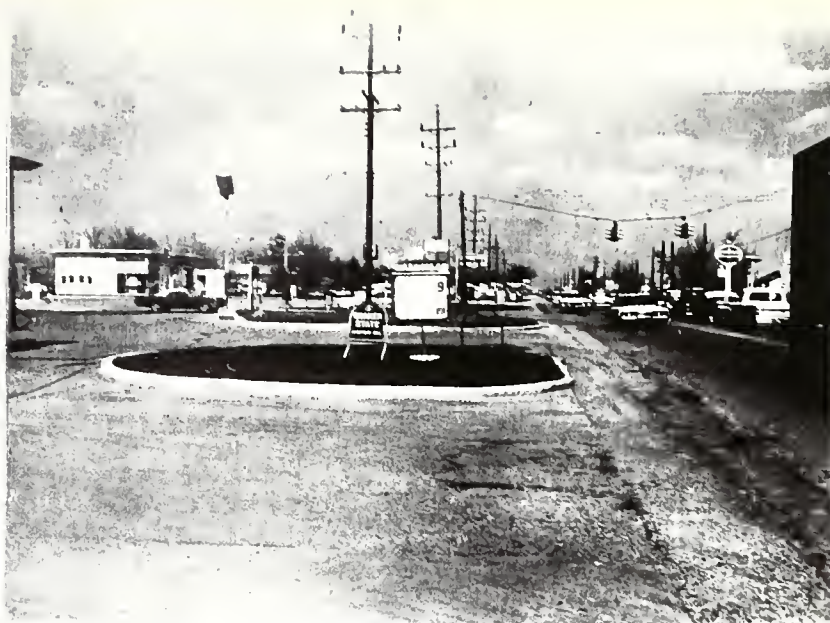
FIGURE 11 SIGNS PLACED IN RIGHT OF WAY

9. Remove all redundant and unnecessary informational signing within the right-of-way. These signs are subconsciously distracting to drivers and cause sight distance restrictions. Many are useless either because they are too small, too far from the roadway, or are obstructed in some manner (Figure 11).

change collisions. These types of accidents occur where unprotected left-turning movements exist. There are heavy left-turn movements from the south and west approaches. A heavy right-turn movement exists from the north approach; the left-turn here is not a large proportion but is a heavy volume. Recent studies have indicated a definite need for left-turn relief at this location.\* The existing outer lanes on the north and south approaches are woefully inadequate for the volume, speed, and weight of vehicles using them to bypass left-turners. The present signal cycle is very long and heavily favors the Bypass; no separate left-turn phases are included. As a result, all traffic, especially left-turns, from the cross street is delayed excessively. There is confusion over proper lane use and interference from nearby driveways in all quadrants. Sign encroachment on the right-of-way is prevalent here (Figure 11).

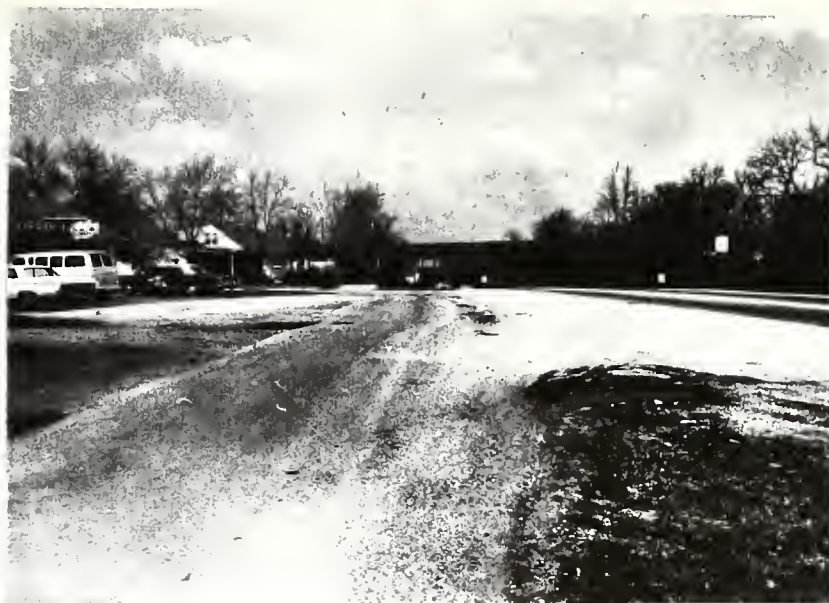
FIGURE 22 NORTHEAST QUADRANT OF INDIANA  
25 INTERSECTION - POOR DRIVEWAY  
DELIMITATION

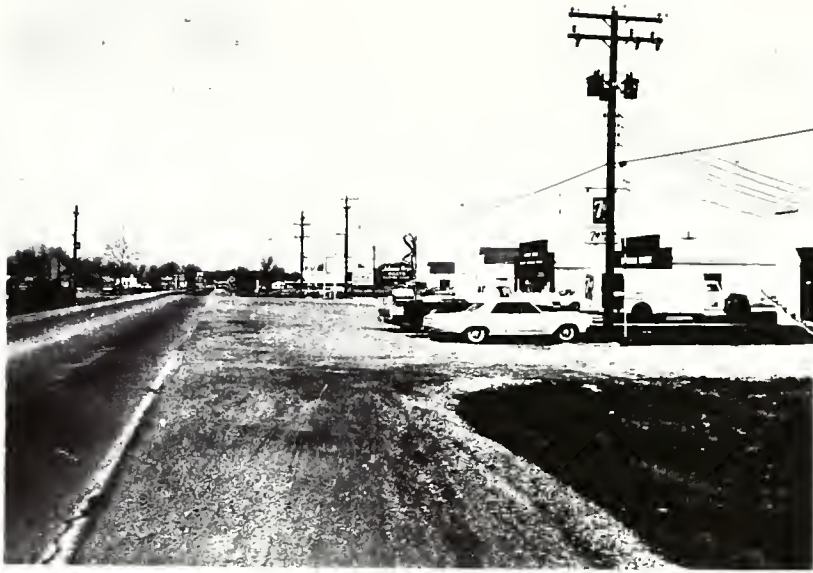
FIGURE 29 EXAMPLE OF POOR DRIVEWAY  
DELIMITATION
